# Conducting Underway Asset Inspections of Port Macquarie & Cowarra Dams

**By: Murray Thompson**  
**Consultant Water Supply Projects Engineer,**  
**Port Macquarie-Hastings Council**

# Dam Emergency Incident – 9<sup>th</sup> December 2010

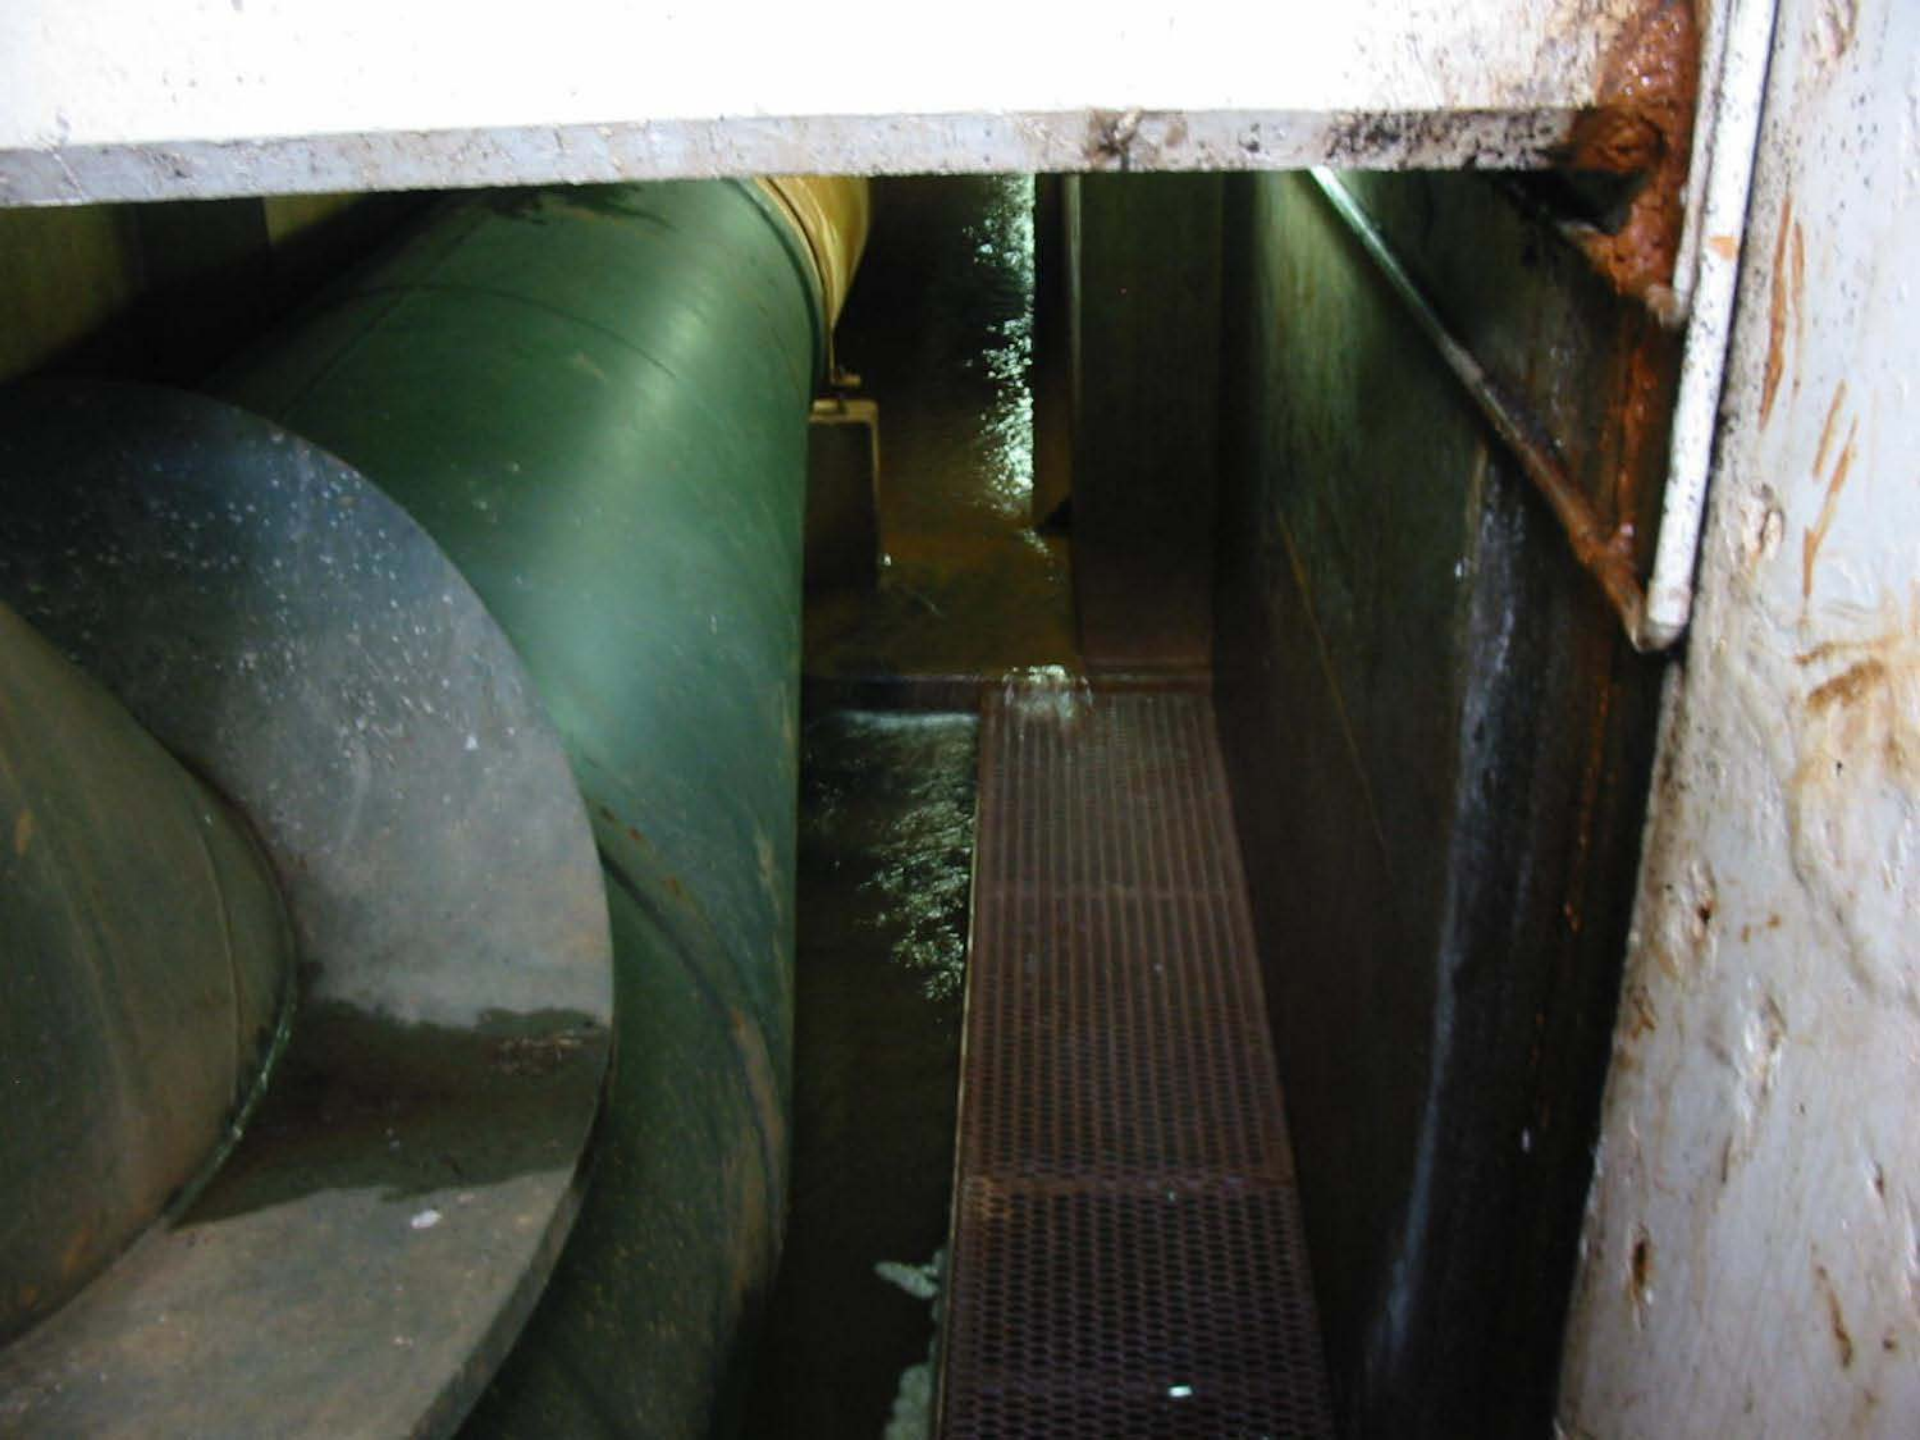
- 8am Thursday 9<sup>th</sup> December 2010, SCADA Alarm alerts Dam Operator to flooding in Port Macquarie Dam Outlet Tunnel
- 8:10am Dam Operator attends site to discover loud noise of water running to drain inside outlet tunnel
- Visual inspection of the tunnel from entry hatch confirmed water in the base of the tunnel & very loud noise of water escaping under pressure
- 8:15am Dam Operator advises Water Supply Manager & Dam Safety Emergency Notification Plan implemented to advise/notify/seek advice from NSW DSC, advise/notify LEMO & SES Controller

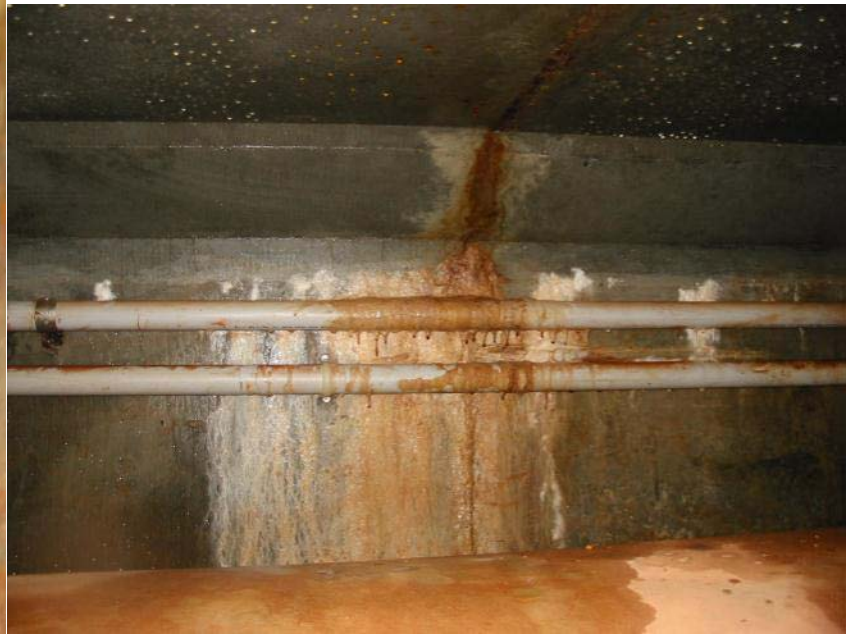
Broken PVC Pipeline ???

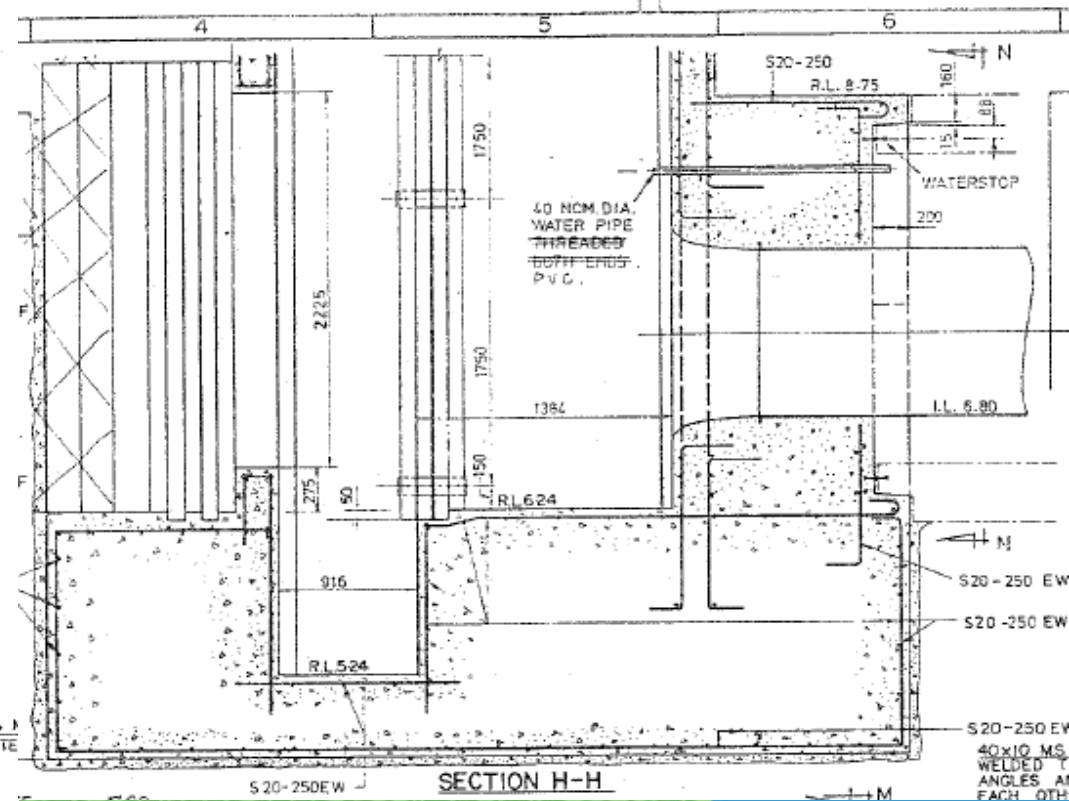
## Intake Tower Cross Sections

Indicating 40mm dia water pipe PVC from base of intake tower into the outlet tunnel

- Work-as-Executed drawings updated to recorded capped-off pipework and removal of 40mm dia PVC water line from Intake Tower into Outlet Tunnel,
- Incident Report completed and submitted with photographs to both NSW DSC and local LEMO,
- Debrief held with PMHC staff involved with the Incident Management and Repair activities, and
- Diving inspection programme updated to include future underwater inspections of the capped-off PVC pipework inside the Intake tower
