# Asset Risks – wastewater system integrity and environmental risk

## *West Gosford Major and Sewer Rising Main – Case study*

Jamie Loader, Director  
Water and Sewer

Date: October 2025

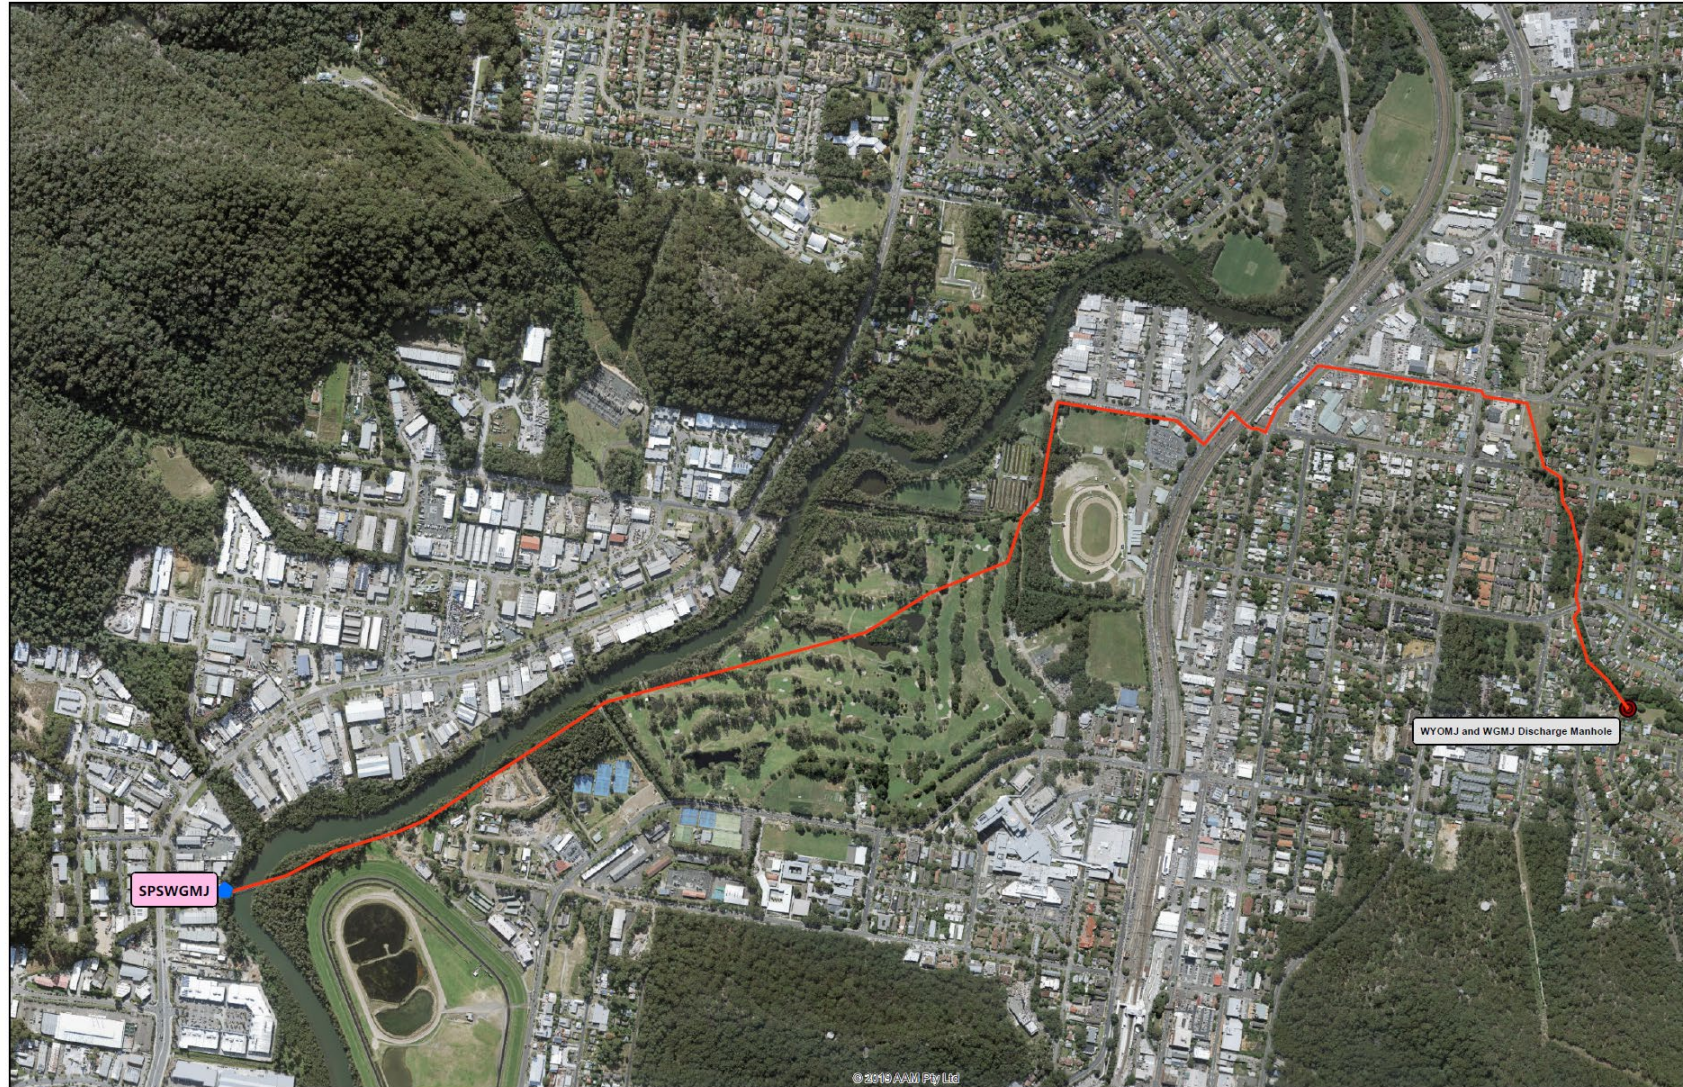
*Aerial view of  
complete  
alignment of  
WGMJ SRM*

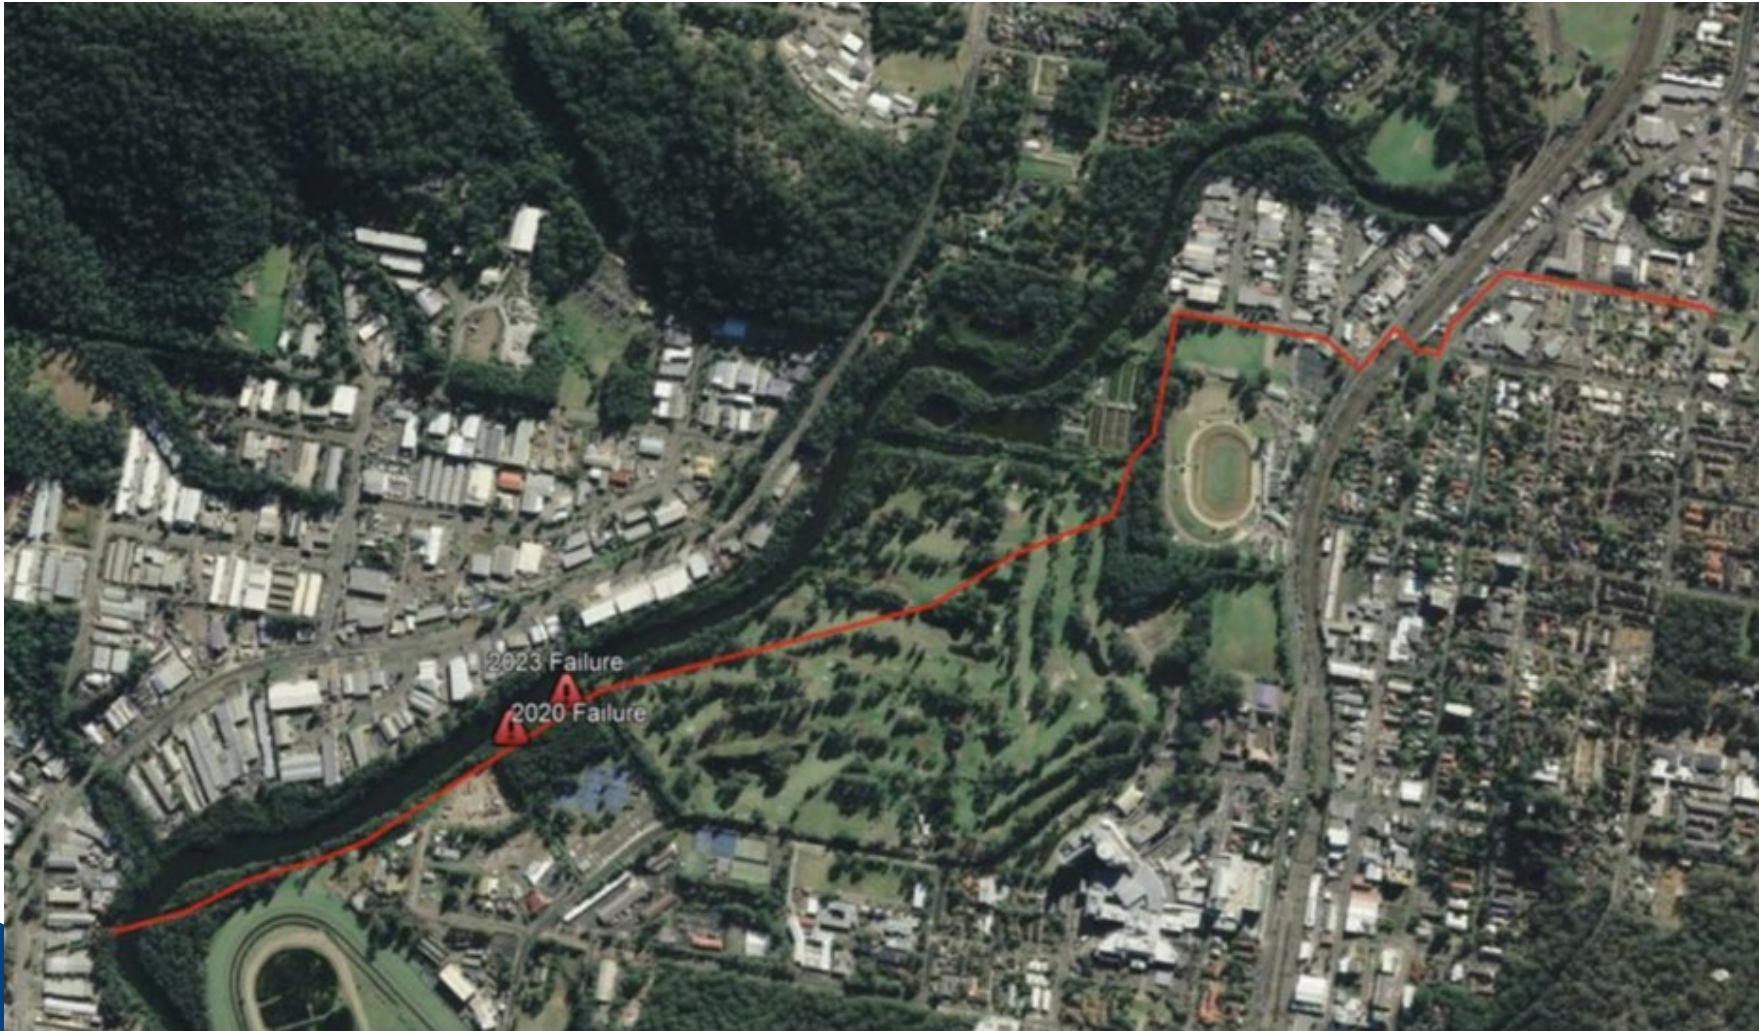
*Existing WGMJ  
SRM with  
approximate  
locations of main  
break*

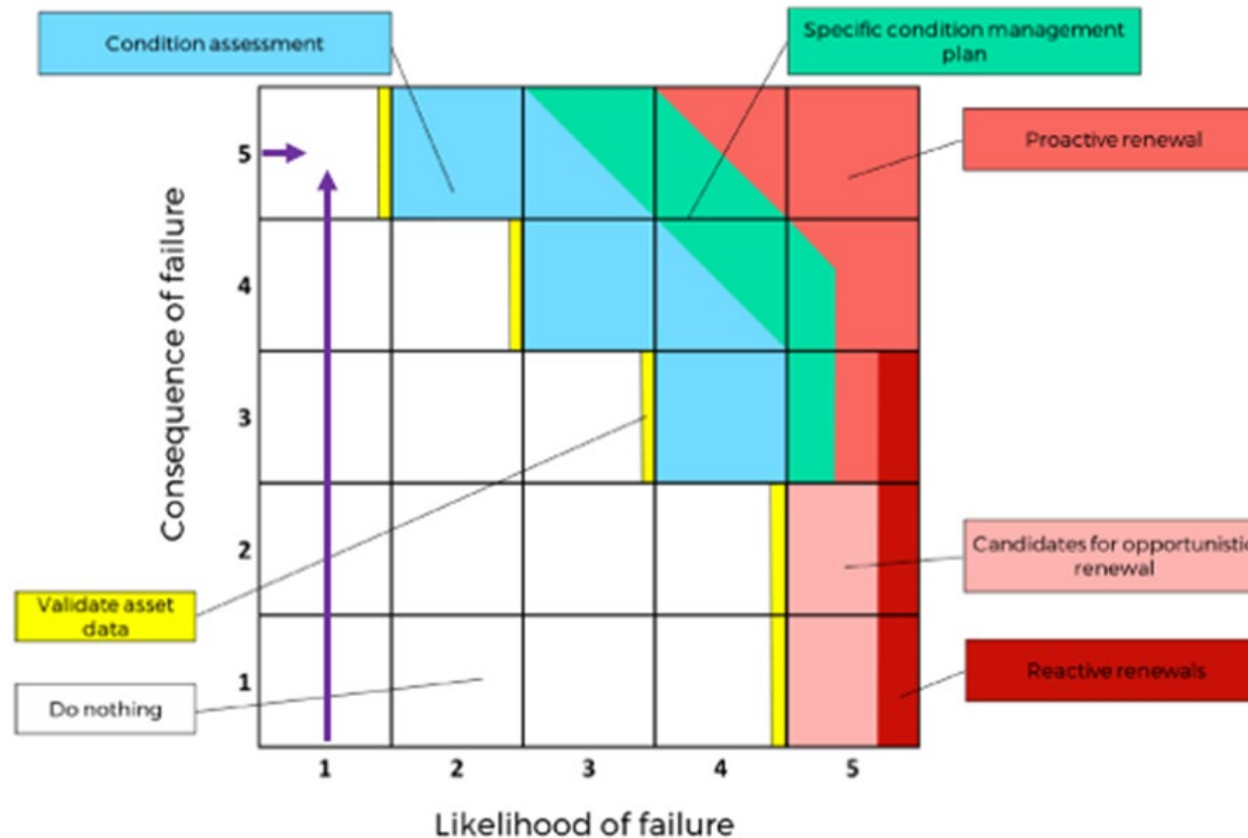
Initial criticality score prior to 2020 failure  
(1<sup>st</sup> iteration of CCC PMCA noting that 'do nothing' signifies continue to monitor performance and update risk scores as relevant)

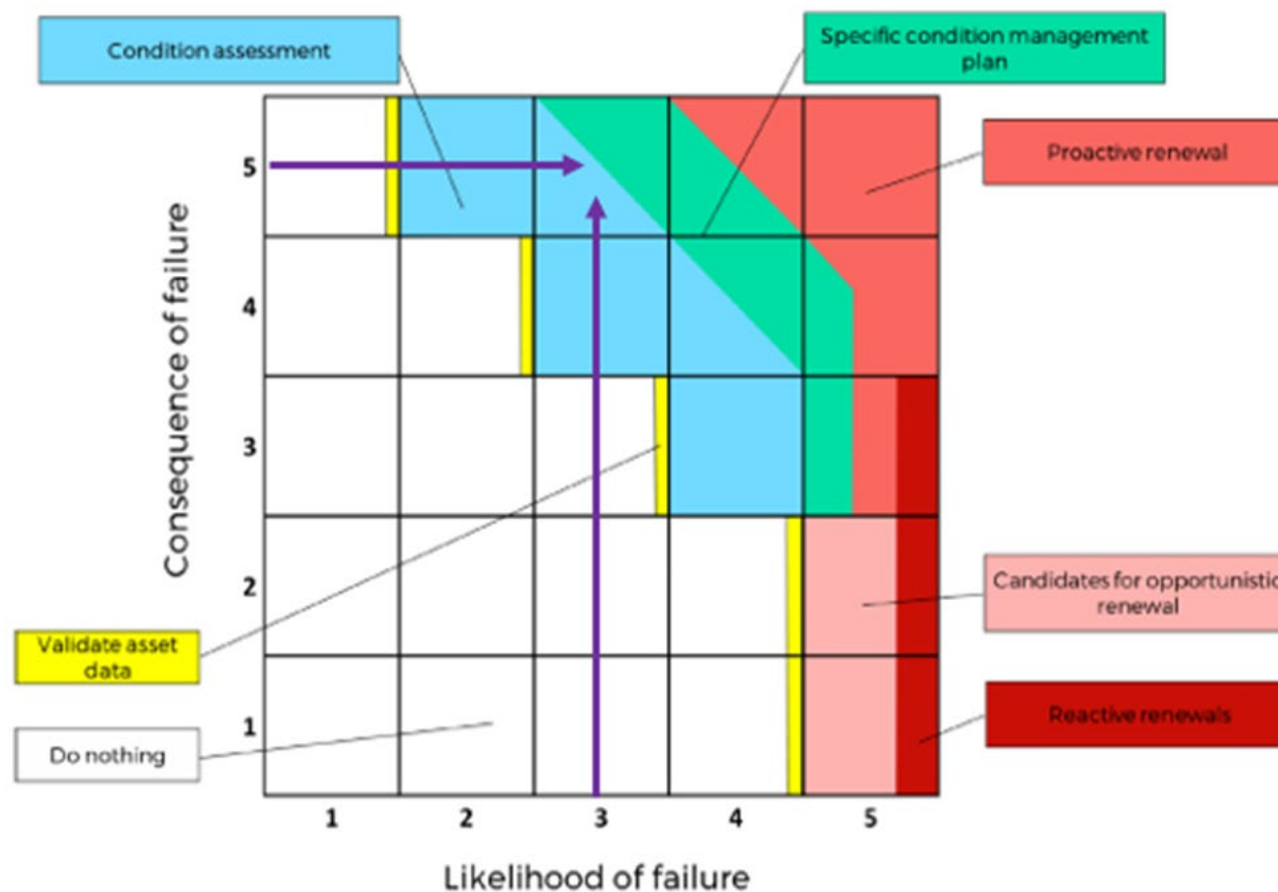
Criticality score following 2020 failure  
(condition assessment triggered to further understand risk of failure along whole of pipeline)

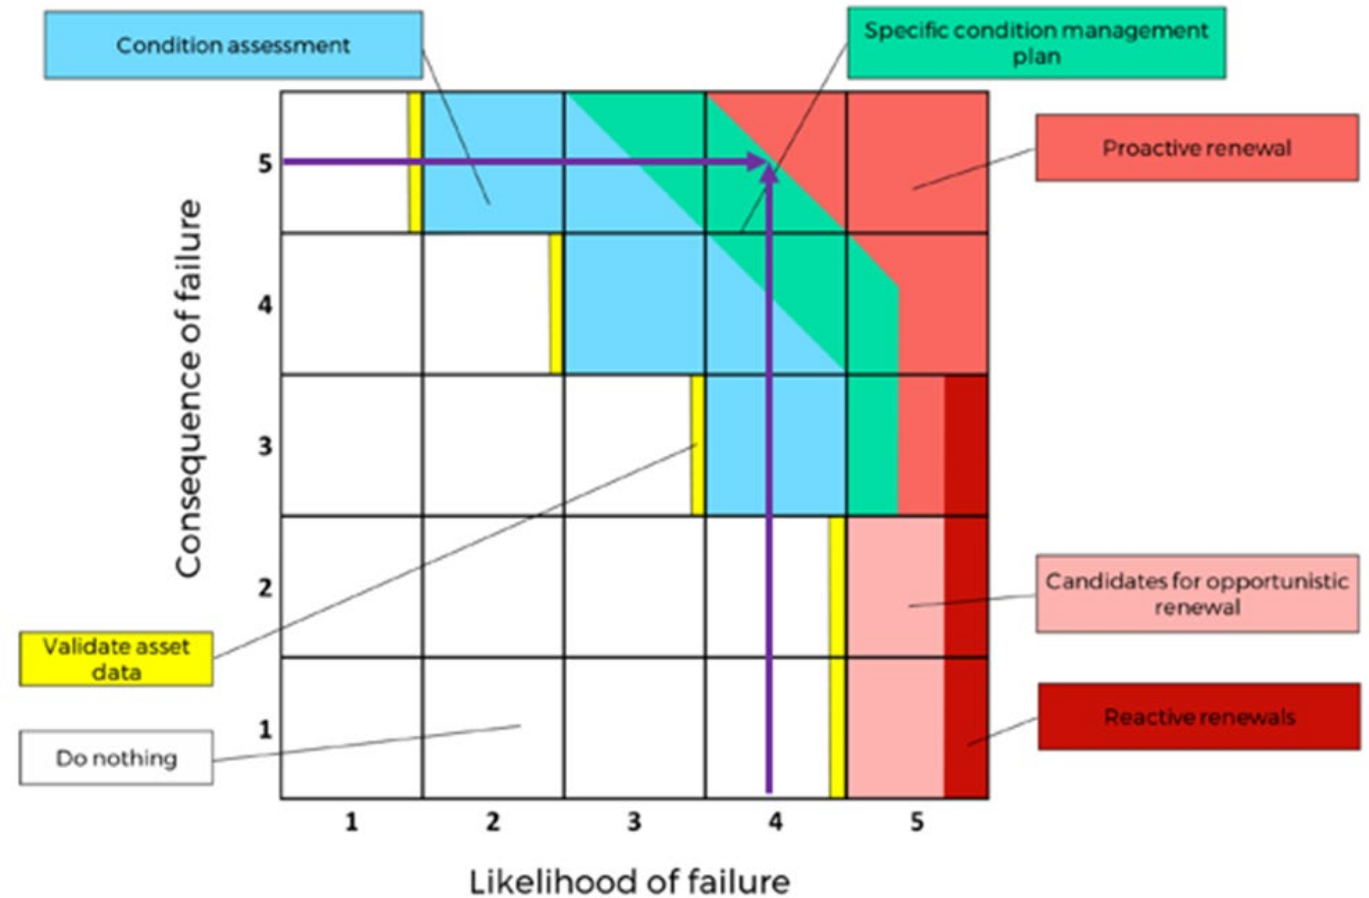
Criticality score following 2023 failure (proactive renewal planning commenced and increased pipeline monitoring implemented while options/design/construction is undertaken). Condition assessment estimates remaining useful life of less than five years for highest risk pipe segments and less than 8 years for adjoining pipe segments

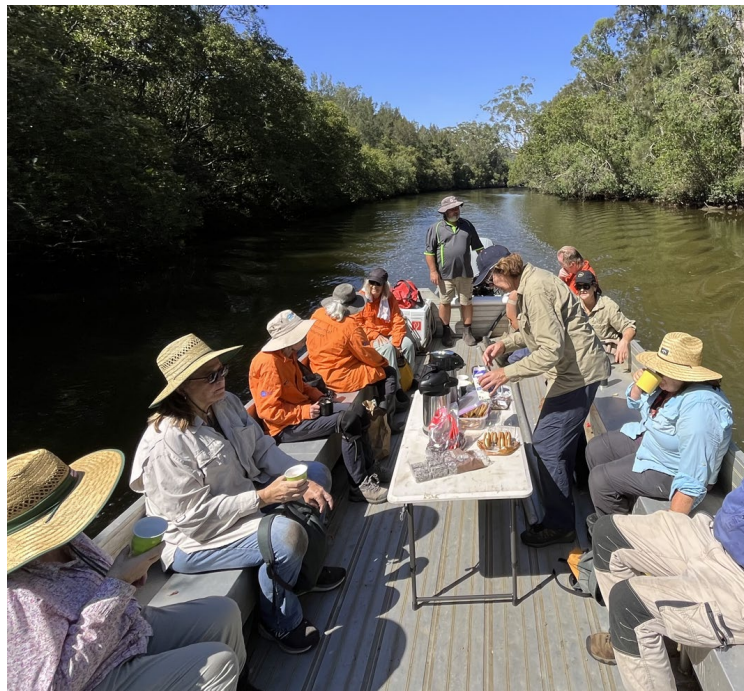
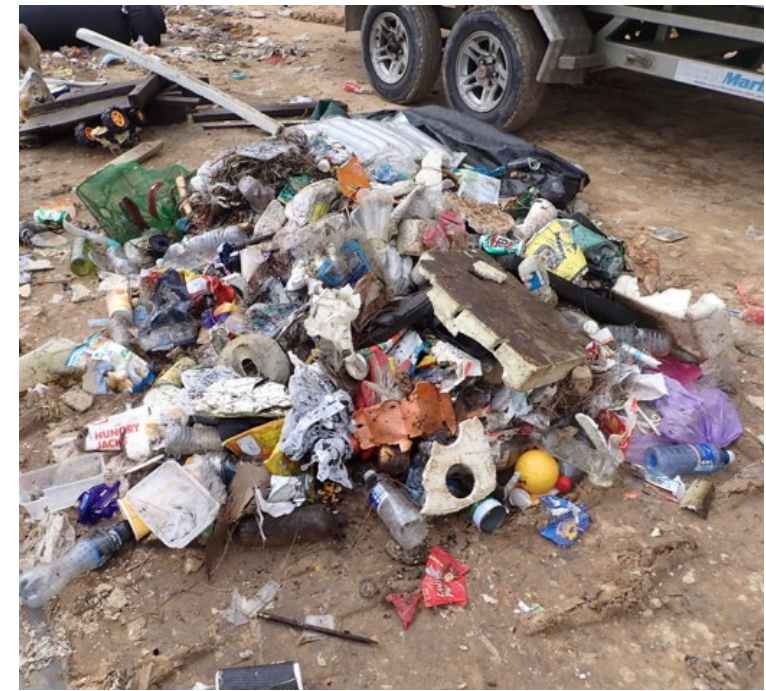
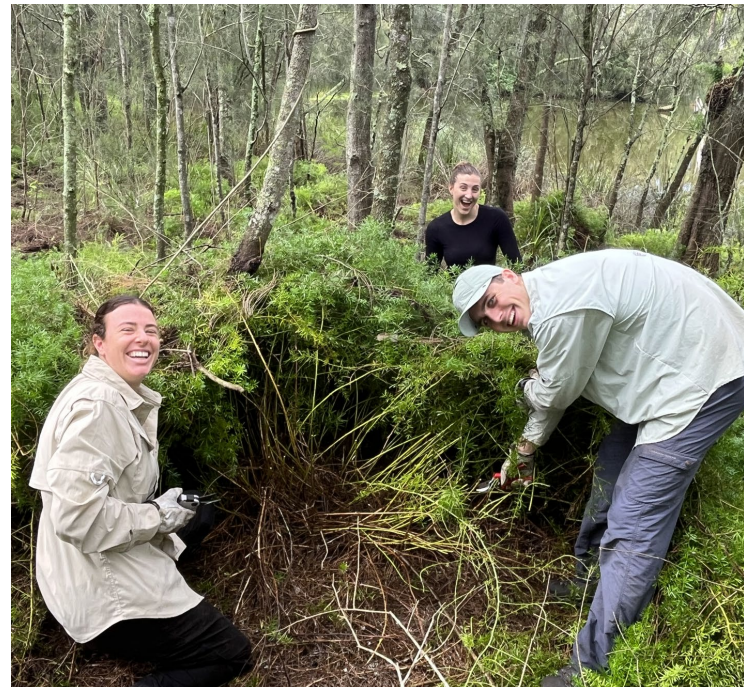
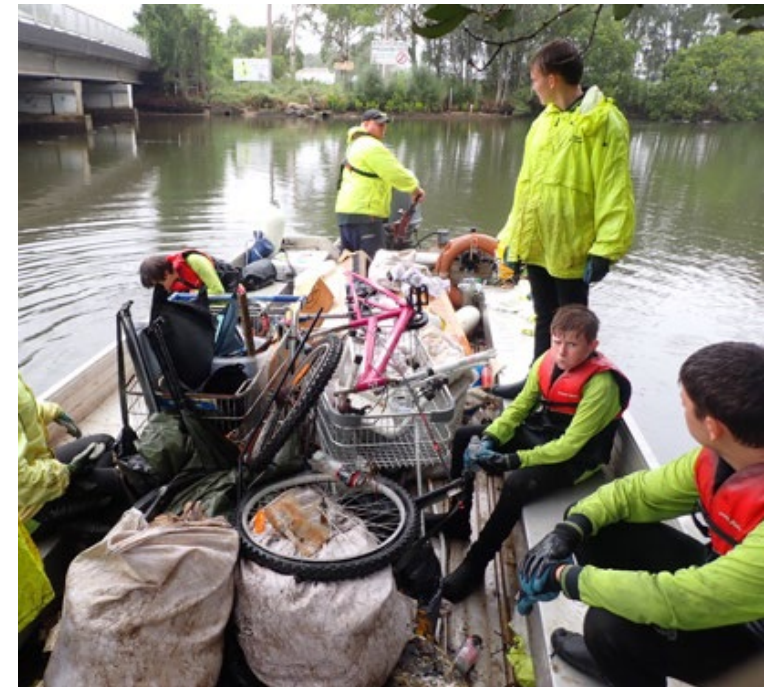
The team have completed 6 Floating Landcare trips, which included 55 volunteers, 24 hours of volunteered time, and total vegetation removal of 1,950m<sup>2</sup>.

The team have completed 3 Clean4Shore trips, which included 23 volunteers, 65 hours of volunteered time, and total litter removal of 980kgs.

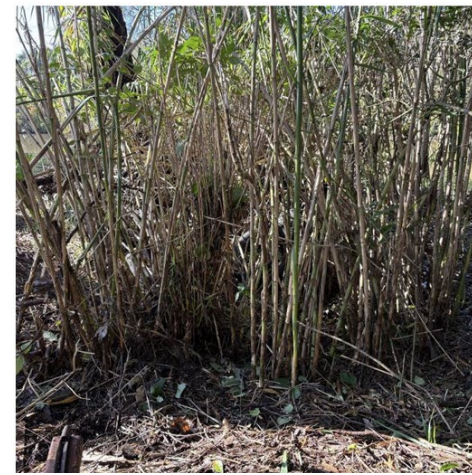
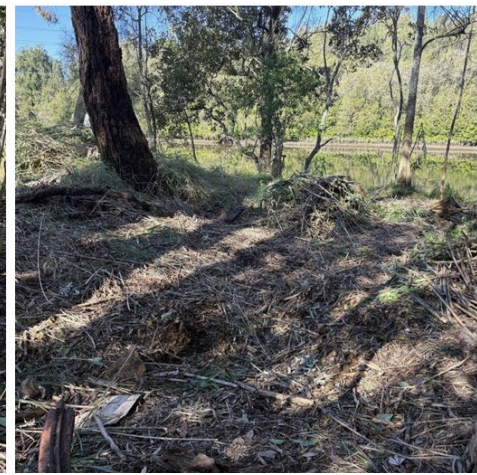
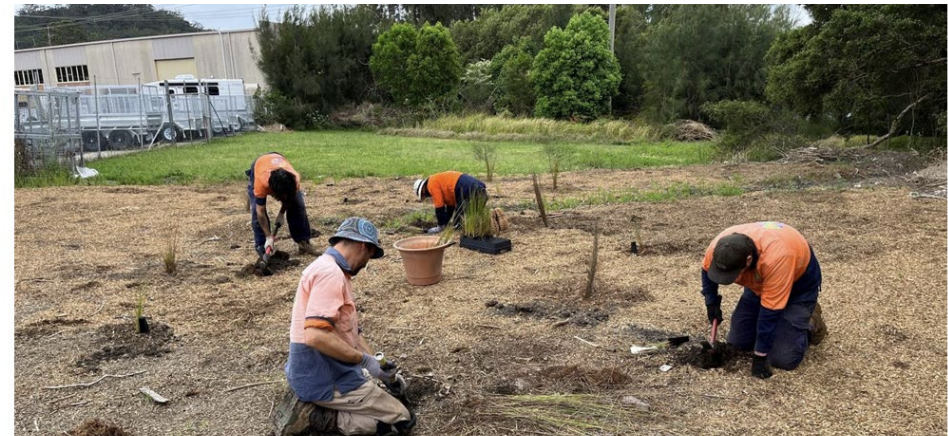
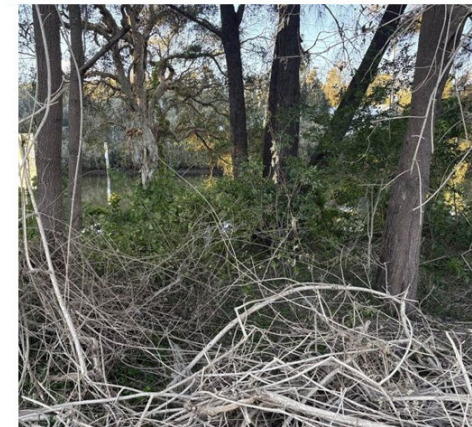
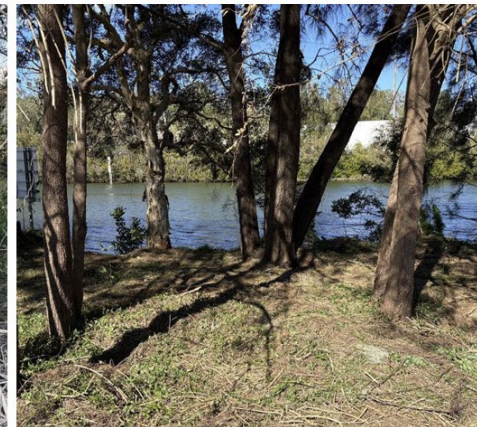
**Lantana, Cassia and Asparagus Fern Control**

CEN have currently completed a total of 376.5 hours of work and rehabilitated 17,640m<sup>2</sup> of land to date, per the scope of works. This includes primary weed control, mulching and native planting to rehabilitate areas of vegetation loss and encroachment. Works are due to be completed by end of November 2025.

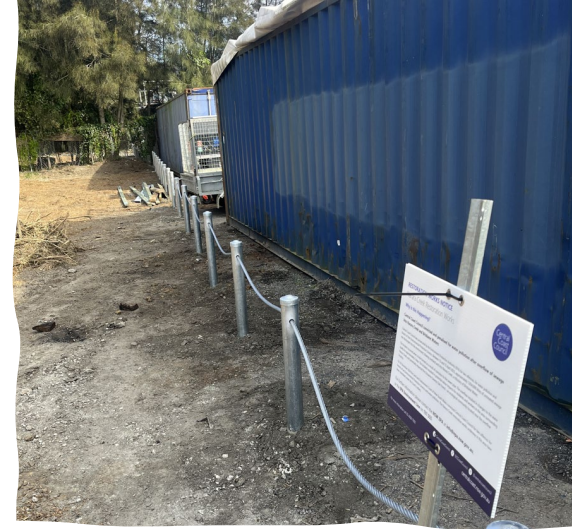
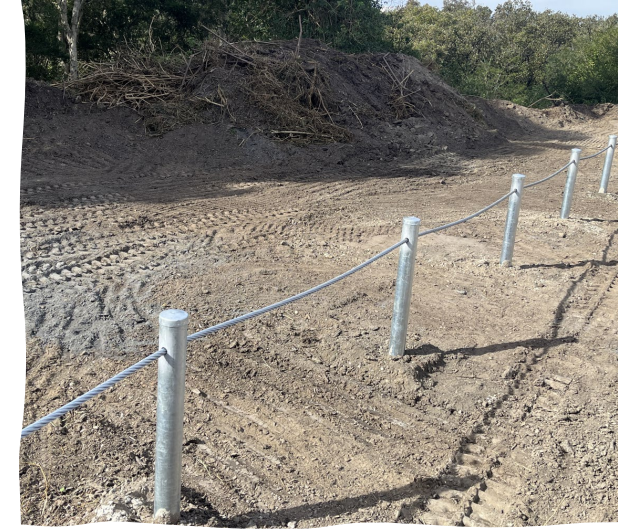
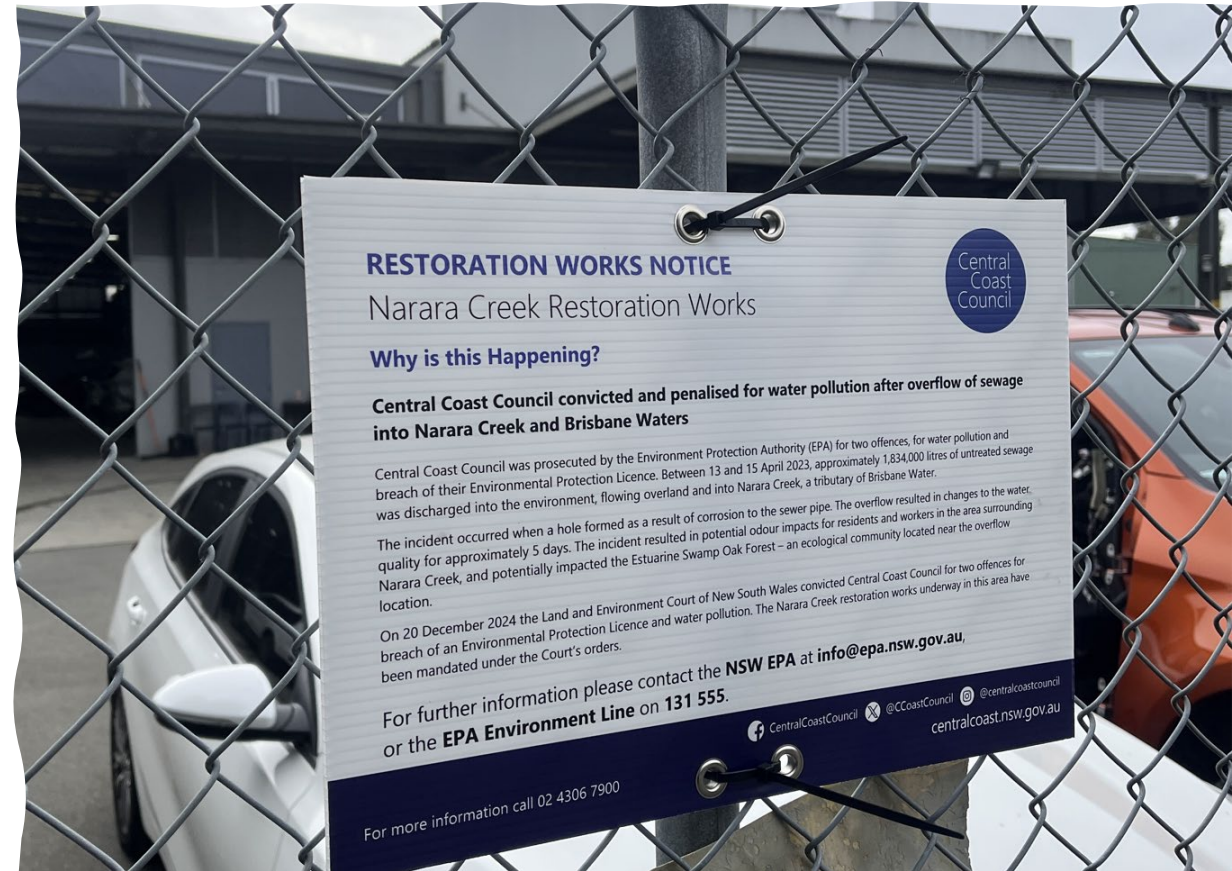
Fencing works were undertaken and completed in July 2025.

As part of this process, several encroachments were identified for removal and were successfully removed by either the adjoining landowner or Council.
