# Conducting Underway Asset Inspections of Port Macquarie & Cowarra Dams

**By: Murray Thompson**  
**Consultant Water Supply Projects Engineer,**  
**Port Macquarie-Hastings Council**

# Dam Emergency Incident – 9<sup>th</sup> December 2010

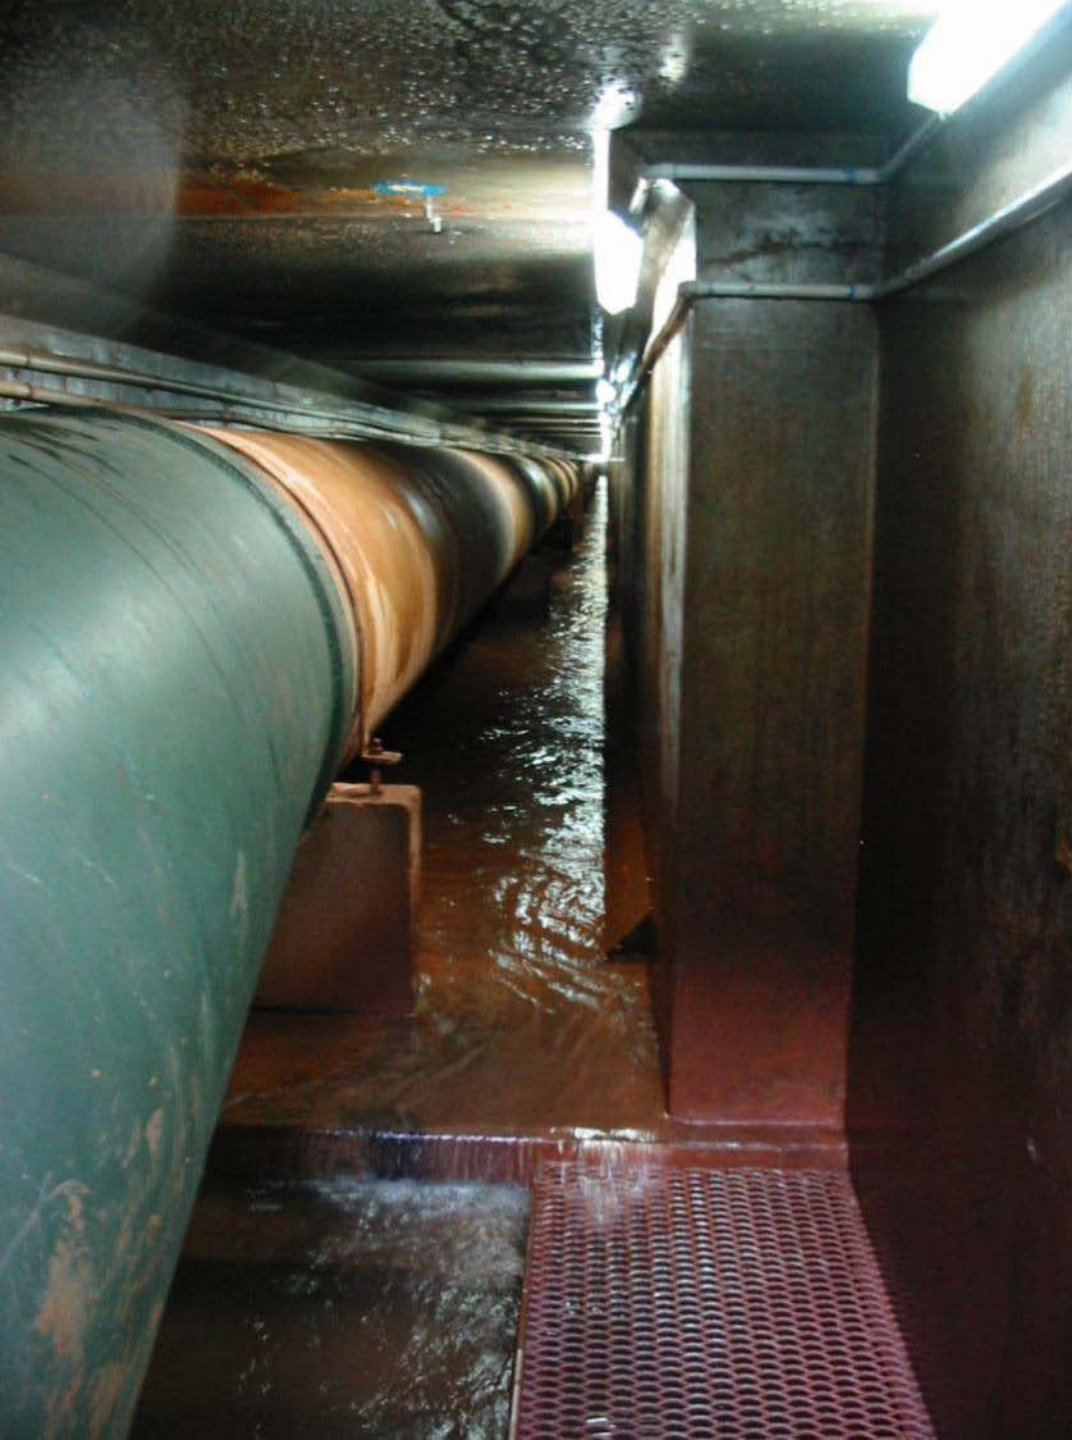
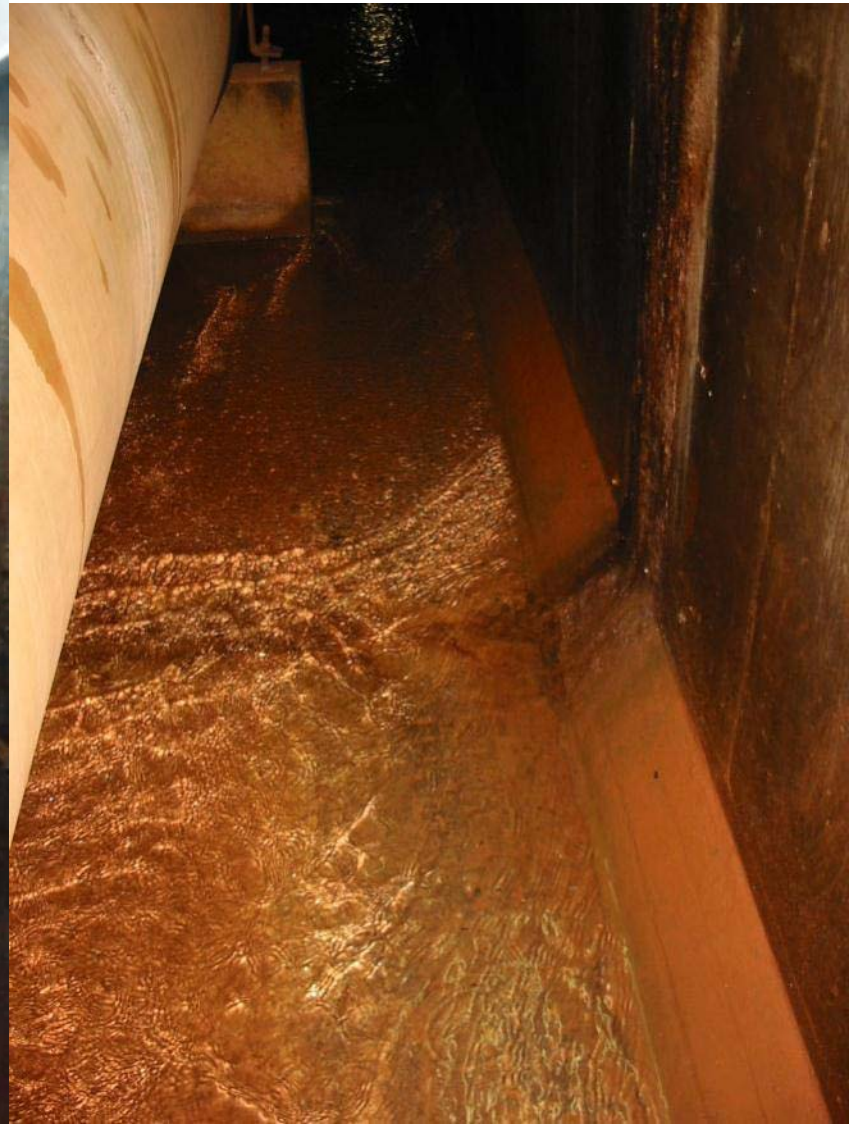
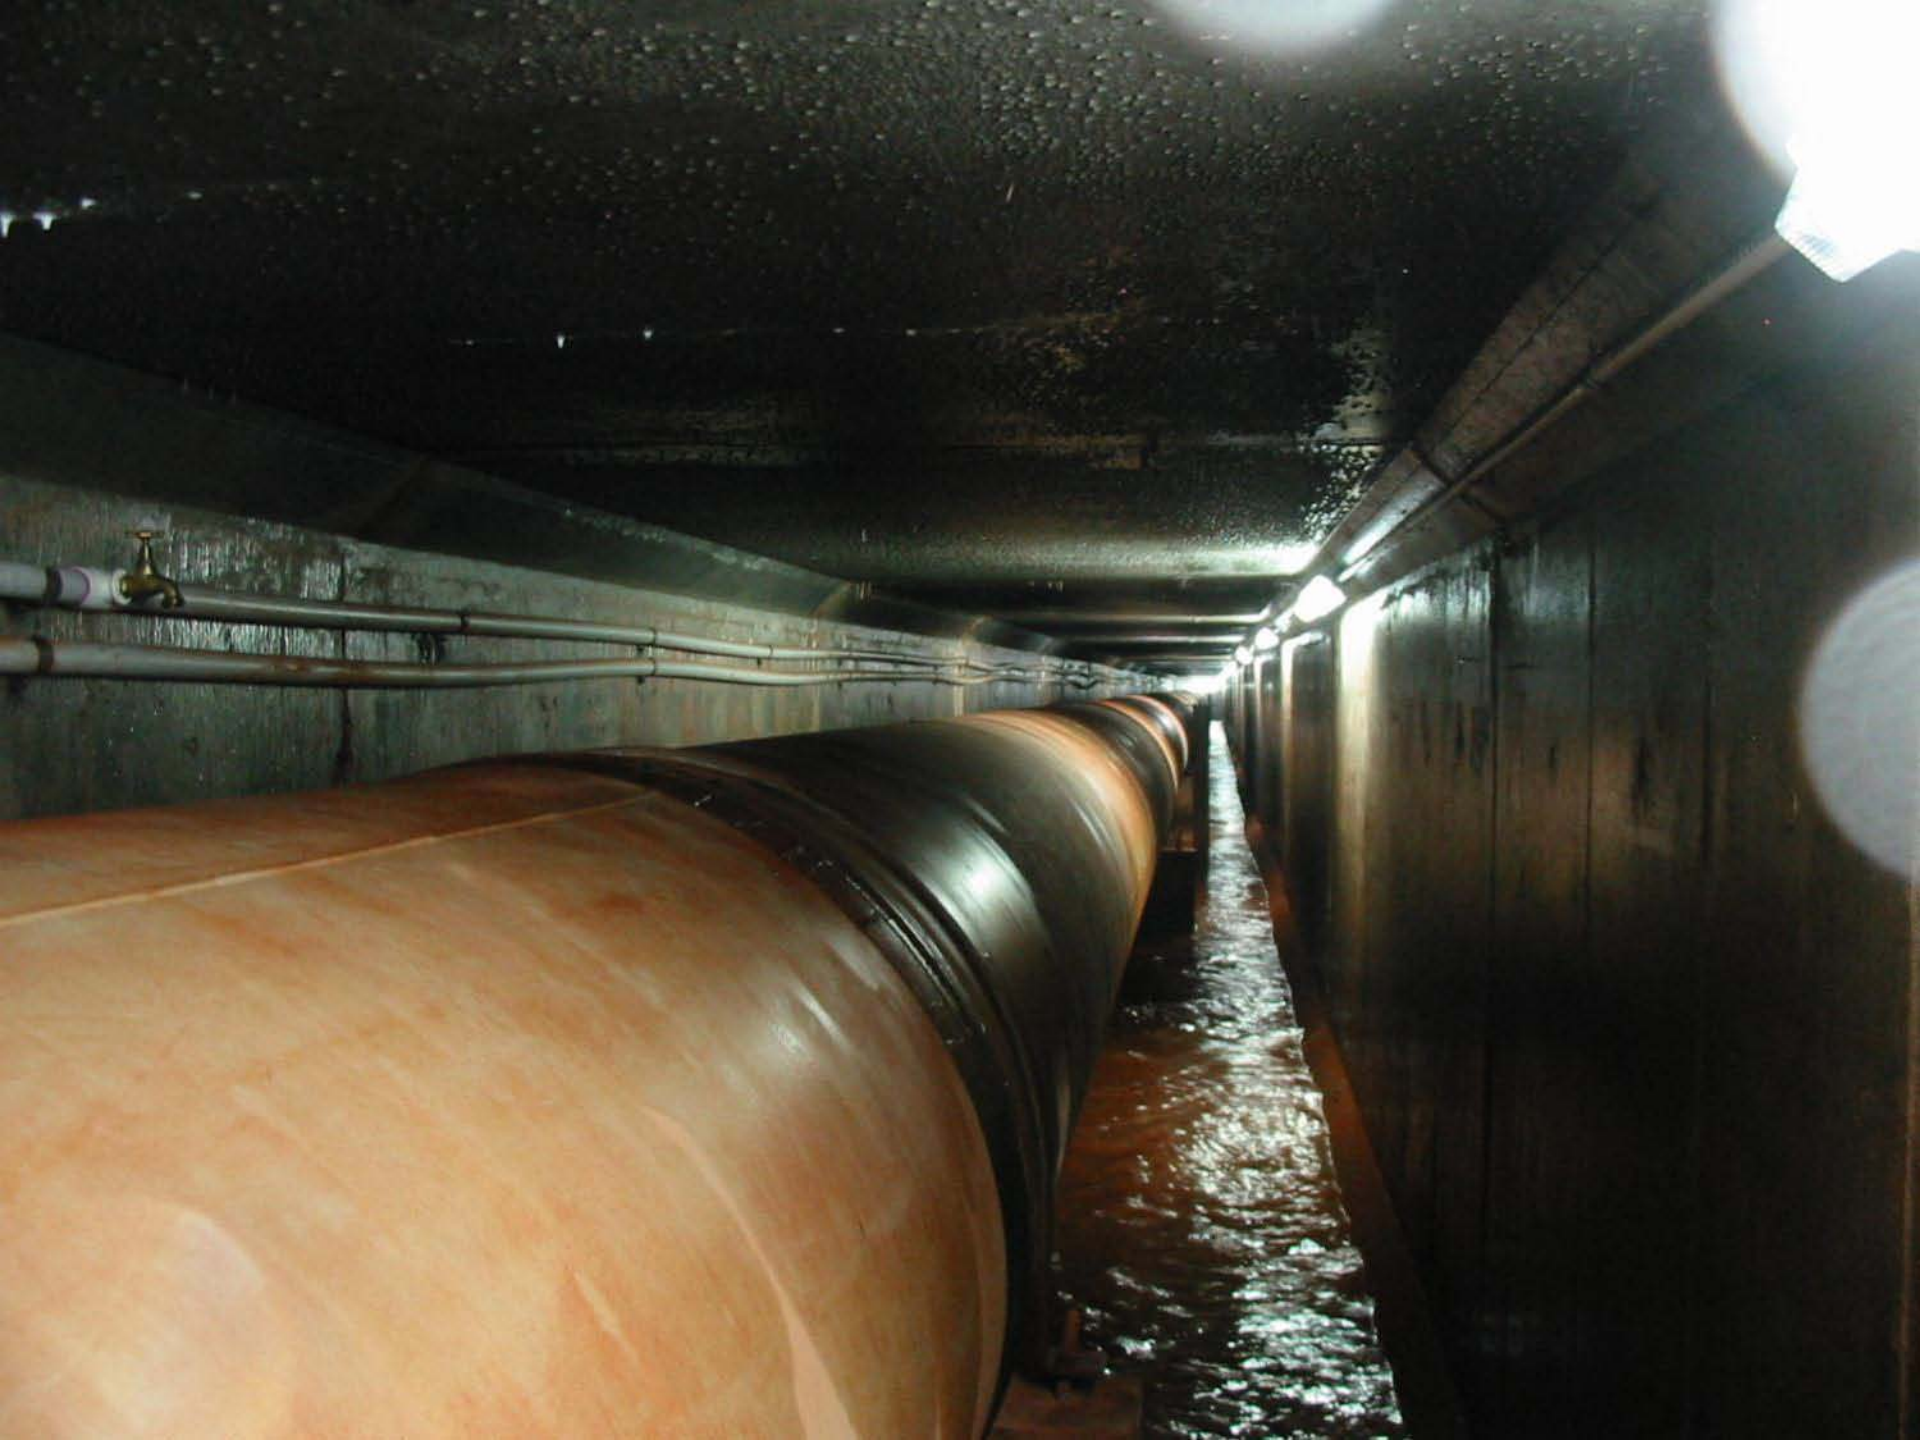
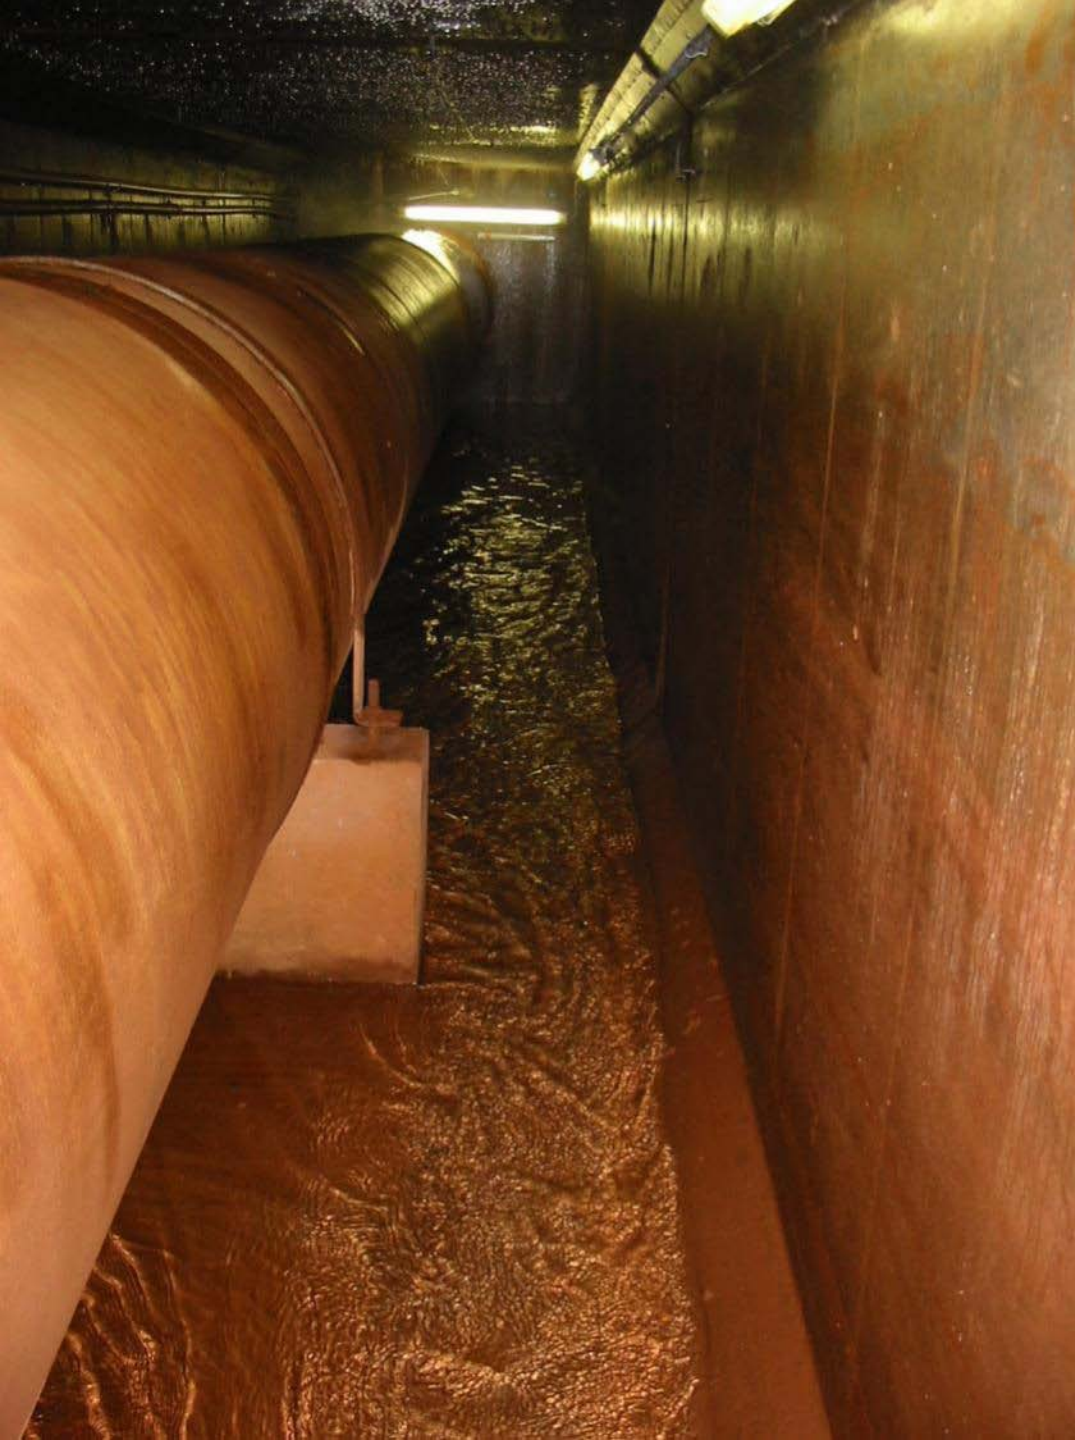
- 8:30am Dam Intake Tower accessed by boat & all window gates closed, with water leakage in the Outlet Tunnel being continuously monitored
- 8:45am Dam Pumping Station isolated & scour activated on outlet pipeline
- 9:00am water leakage in Outlet Tunnel reduced and noise of escaping water also greatly reduced
- 9:30am all isolations confirmed & confined spaces entry made inside Outlet Tunnel by PMHC staff
- 9:30am into the unknown the brave few proceeded with some caution & great deal of apprehension !!!!!

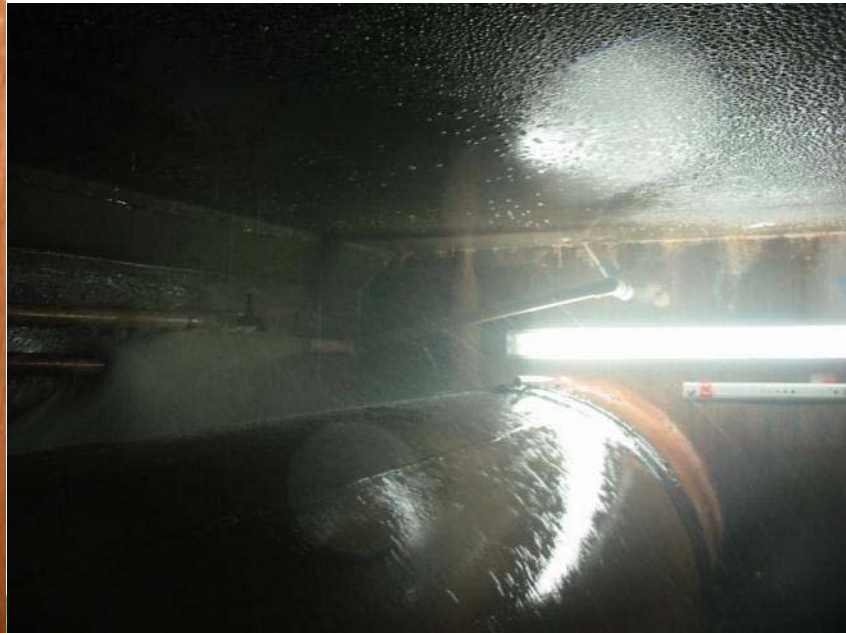
Broken PVC Pipeline ???
